# Material Analysis and Tests on Three Samples of Retaining Springs in the Fuse Components of the Antipersonnel Obstacle Breaching System

ARL-TR-1413 July 1997

### **Army Research Laboratory**

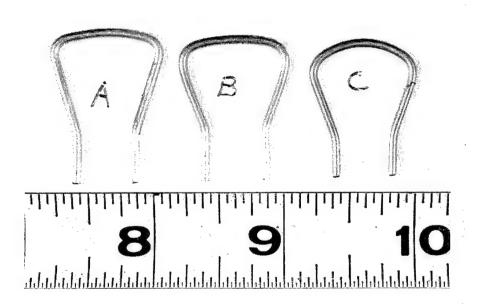
Figure 1. <u>View of three APOBS stainless steel retaining spring samples based on slight variations of the design configuration.</u>

Figure 1 shows three u-shaped retaining springs of slightly different design configurations. Based on the fuse tests performed on the APOBS fuse components, few failures occurred with spring-A design; whereas, the other two designs did not fail. Marine drawing 87012E3134 specified the retaining spring to be made of a chrome-nickel stainless steel conforming to American Society for Testing and Materials (ASTM) A313, Type 302, Condition B, which means severely cold-worked to spring temper. The diameter of the wire specified on the drawing for the spring was  $0.071 \pm 0.003$  in. After the spring was fabricated to shape, it was to be stress-relieved at  $600^{\circ}$  F for 30 min. According to the information provided on the spring samples, the design-C springs, which were proposed for use in the fuse components, were supposed to be made of precipitation-hardening steel 17-7PH, Condition CH900, which means severely cold-worked, fabricated to shape, and then aged at 900° F for 1 hr to higher strength.

It is speculated that the few failures with the spring-A samples were caused by the design configuration that was slightly different from the Marine drawing, which may not allow full engagement of the spring in the APOBS fuse components.

The design of the retaining spring for use in the APOBS fuse components may have to be taken into consideration if different from the original design on the Marine drawing.

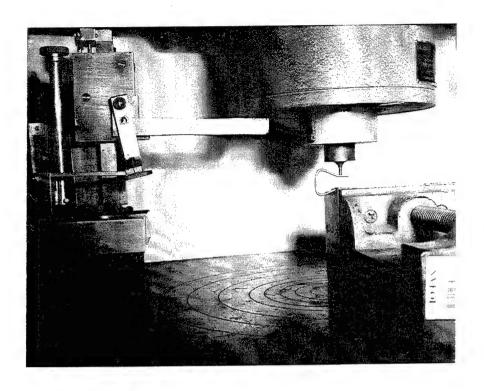
The special spring compression tests were performed on the spring samples in order to obtain the approximate spring rate in terms of pounds per inch. The spring rate may be affected by the slight variations in the spring design configuration among these spring shapes seen in Figure 1. The typical setup of the test is shown in Figure 2. One straight end of the spring sample was clamped tightly in the upper corner jaws of the machine vice (see Figure 3 for a close-up view), which was placed underneath the compression crosshead of the testing machine. A small steel plunger with a small diameter tip end was placed on top of the spring's free end at the slight bend to push it under the load toward the clamped end (see Figure 4). A deflectometer was used to record the spring free end deflection vs. the applied compression load.

Figure 2. View of the spring compression test setup to determine the approximate spring rate in terms of pounds per inch. One end of a spring-B sample was clamped in the upper corner of the machine vise. A small plunger will push the free end closer to the clamped end when the load is applied in compression. A deflectometer on the left records the deflection of the free end during the test.

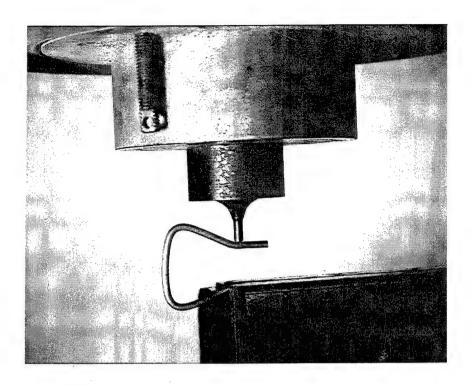
Figure 3. Close-up view of the spring sample prior to the compression test. A small plunger with the small end tip was placed between the compression head of the testing machine and the spring's free end.

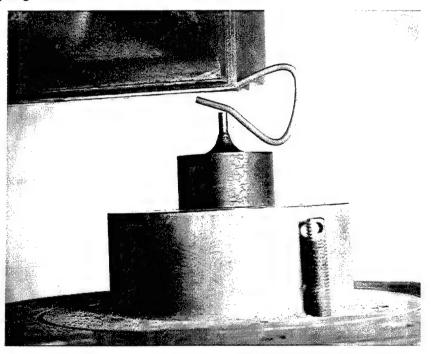
Figure 4. <u>Close-up view of the spring sample showing the free end compressed close to the clamped end in the machine vise while under compressed load.</u>
